**CITY OF PINOLE
SEWER MASTER PLAN
MAY 2008**

SEWER MASTER PLAN

CITY OF PINOLE
SEWER COLLECTION SYSTEM
MASTER PLAN

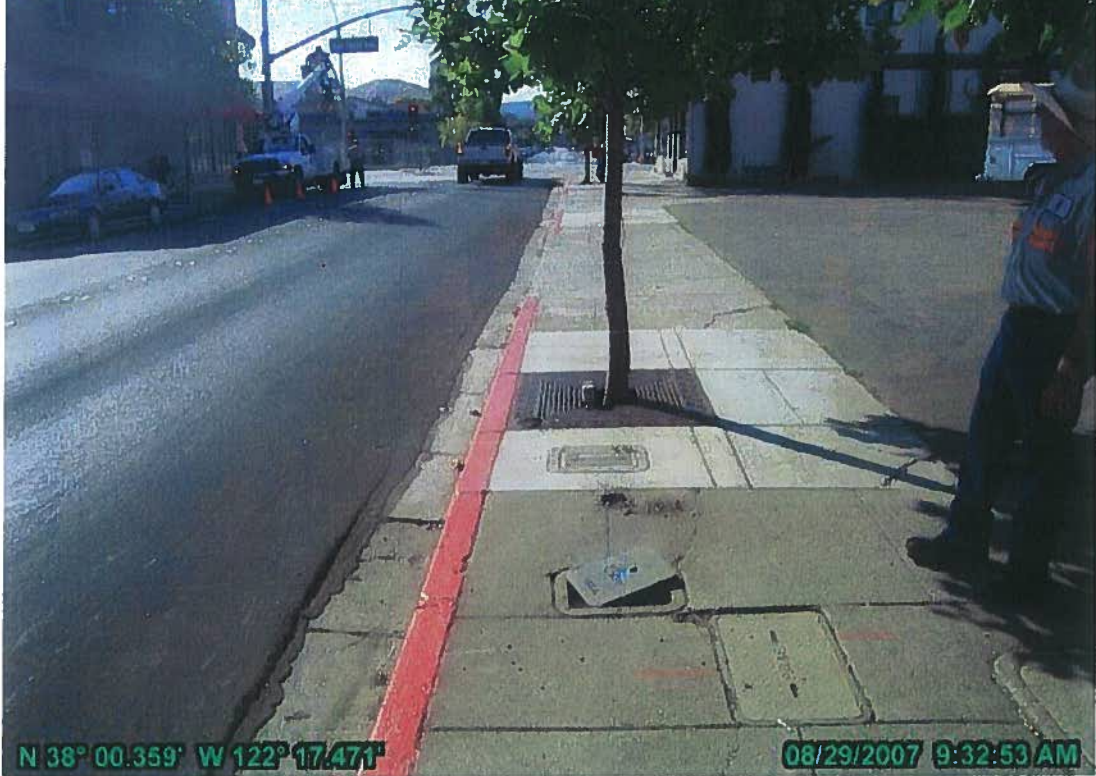
Pinole Smoke Testing Basin 6 Defect 27 - 660 Tennent - Cleanout @ sidewalk

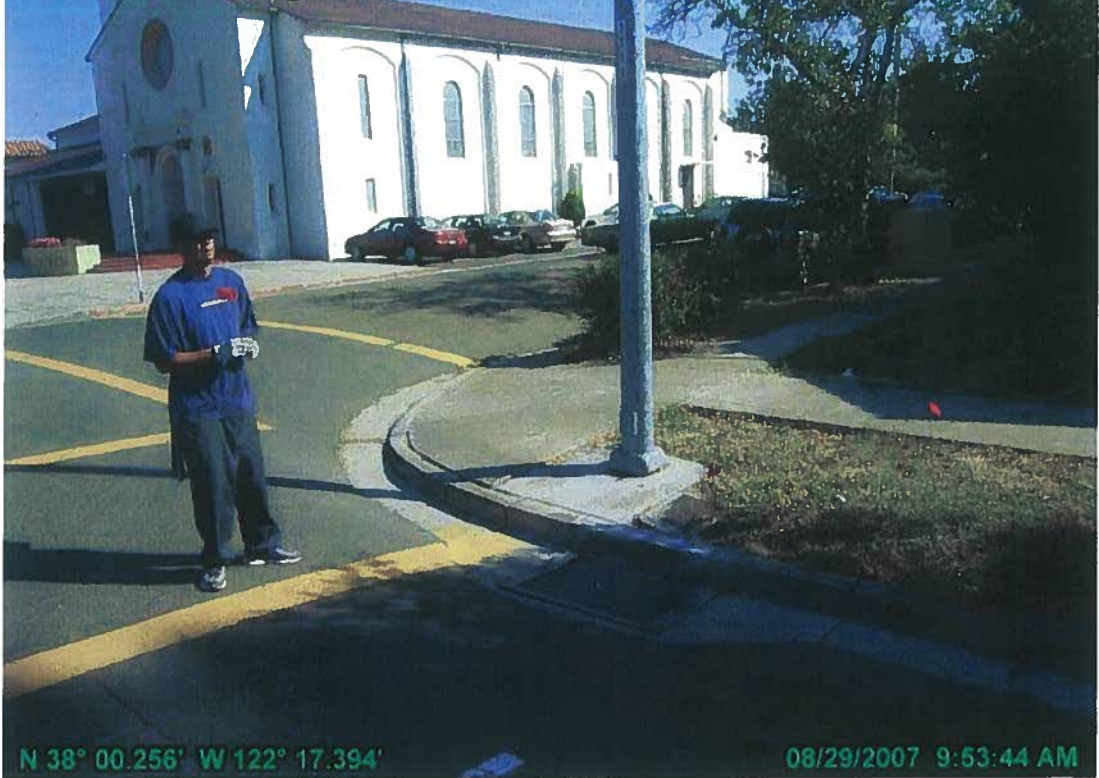
Pinole Smoke Testing Basin 6 Defect 28 - Tennent & Plum - Storm Drain
