**CITY OF PINOLE
SEWER MASTER PLAN
MAY 2008**

SEWER MASTER PLAN

May 2008

CITY OF PINOLE
SEWER COLLECTION SYSTEM
MASTER PLAN

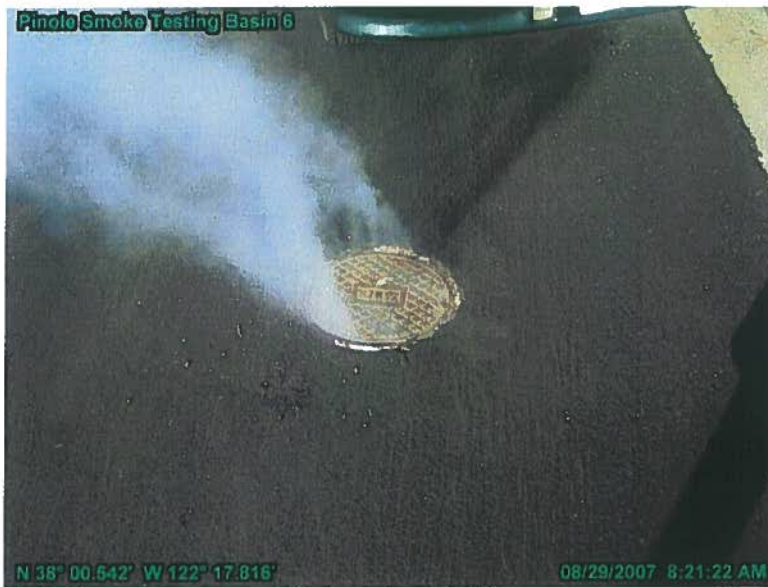
- Based on the increased flow rates in Basin 6 (Old Downtown), Smoke Testing was performed to identify improper connections (See Figure ES-2) that contribute inflow.
- The Smoke Testing positively identified locations of inflow.
- The majority of inflow defects identified were on private laterals.
- No direct connections to the City's storm drain system were observed.
- A few manhole covers positively indicated inflow potential. See Figure ES-4.

Figure ES - 4 Smoke Testing – Manhole
If smoke can get out, then rain can get in.

- The City should completely smoke test the system during Dry Weather during the next year. Subsequent years would inspect 20% of the system per year.
- The defects identified in the smoke testing program should be eliminated.
- The City should promulgate regulations for proper operation and maintenance of private service laterals with special emphasis on the removal of inflow defects.

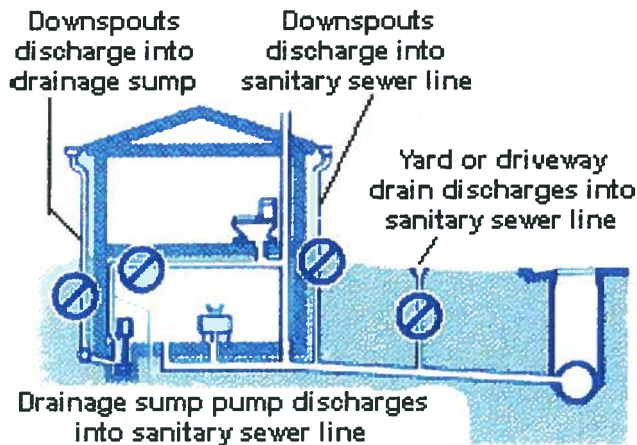
All water from rainstorms and underground seepage should be discharged onto the ground or into a drainage ditch. Some of the common improper connections are shown here.

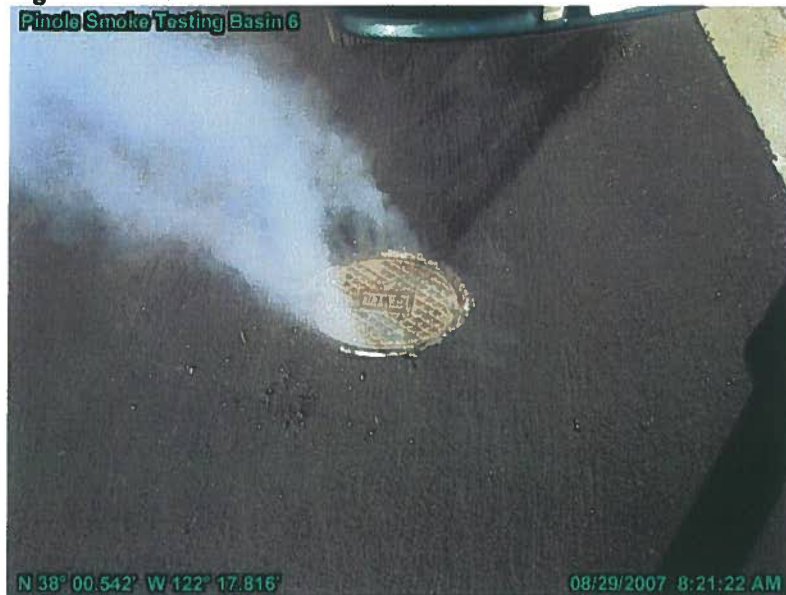
Figure 6-5 Manhole with inflow defect

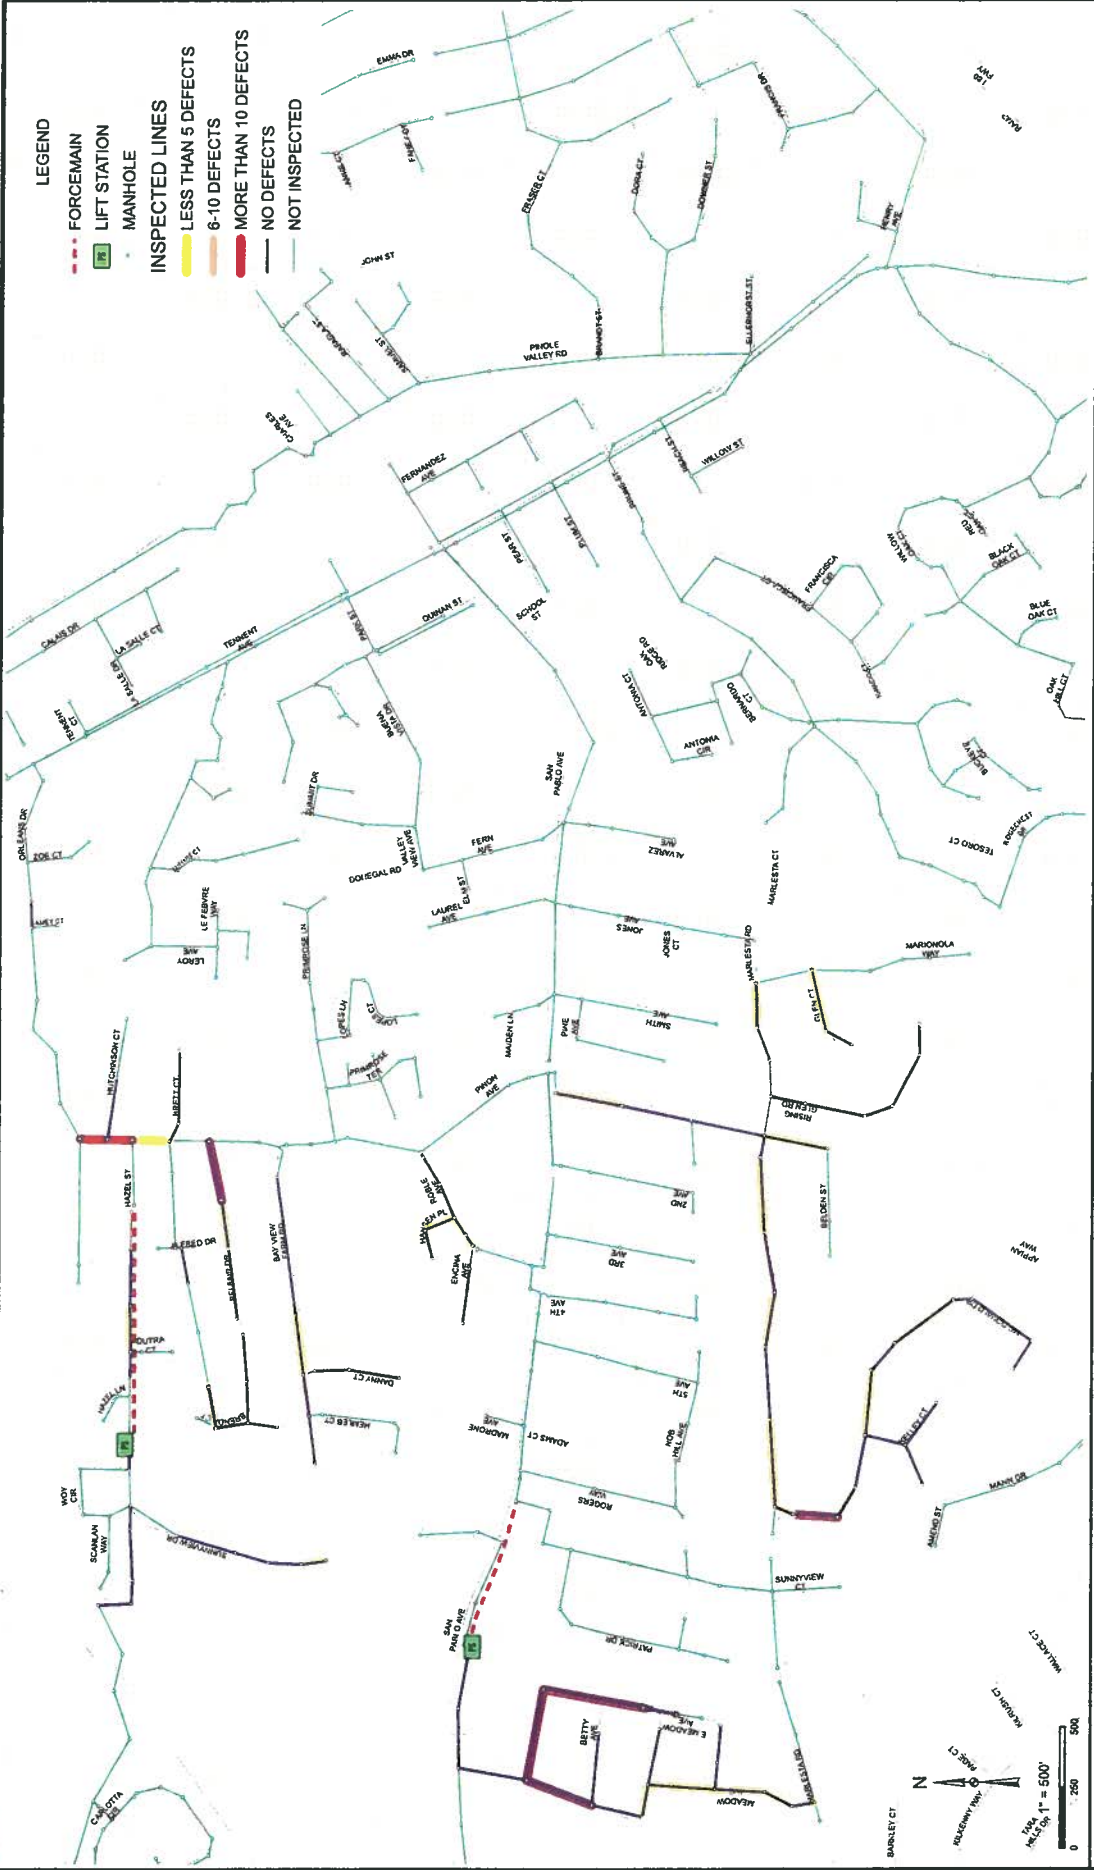
FIGURE 6-8 CCTV INSPECTION LOCATIONS AND DEFECTS

J	1a	4 to 5	Senior Center	Hydro	OF	From parking lot-trail Roots

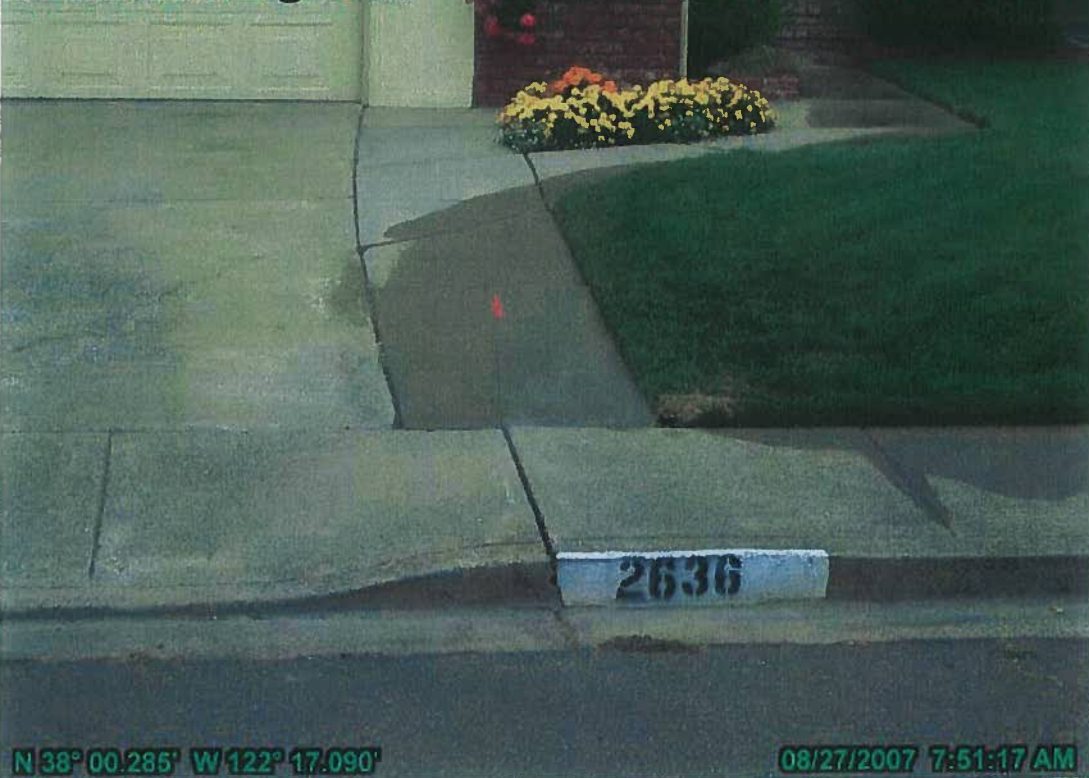
Defect 2 - 2636 Francis - sidewalk

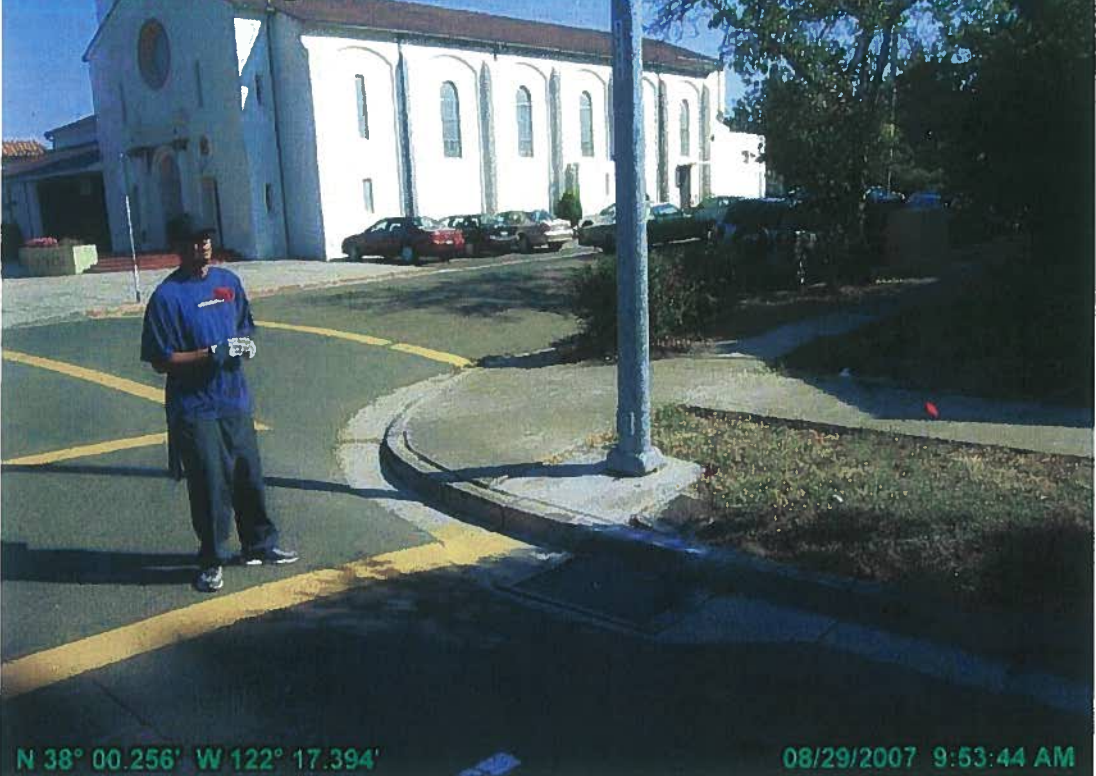
Pinole Smoke Testing Basin 6 Defect 28 - Tennent & Plum - Storm Drain
