**CITY OF PINOLE
SEWER MASTER PLAN
MAY 2008**

SEWER MASTER PLAN

CITY OF PINOLE
SEWER COLLECTION SYSTEM
MASTER PLAN

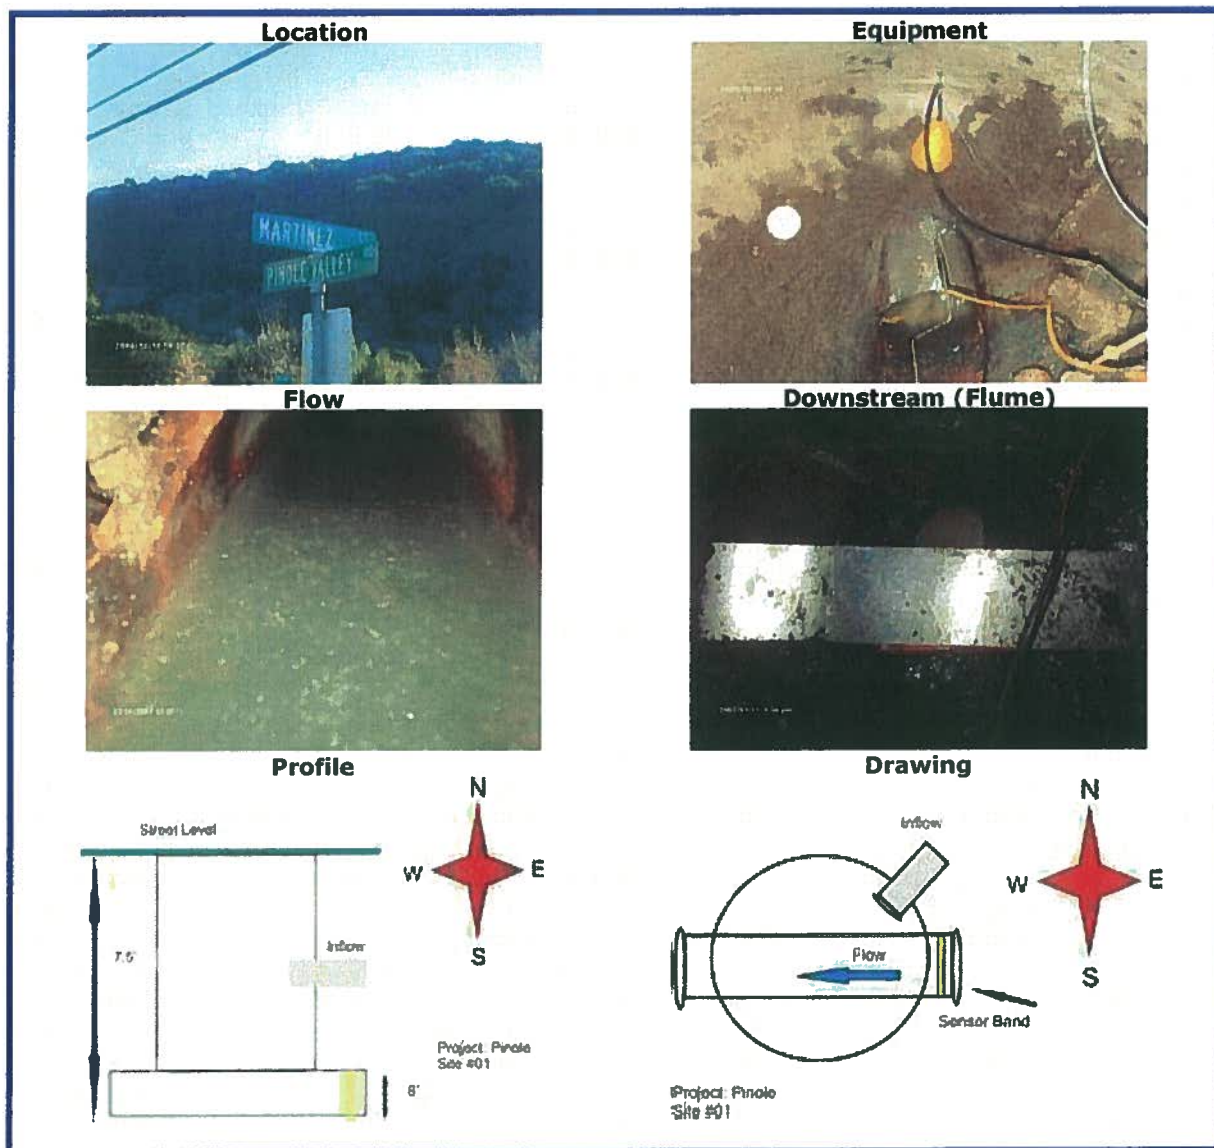
Site 1

This site is located on Pinole Valley Road, near the entrance to Martinez Court. Traffic at this location was deemed to be low, and no additional traffic control was needed to perform safe entry. This manhole features a 10 inch inflow and outflow pipe constructed of concrete and deemed to be in good condition over the course of the study. This site also featured a secondary inflow that entered the manhole approximately three feet above the invert and is believed to have negligible impact in the monitoring application. This location also had a flume installed to overcome hydraulic challenges associated with low flow. Monitoring at this location was successful as hydraulic conditions at this site were deemed to be good.

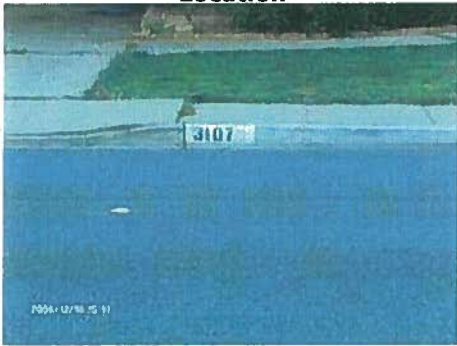
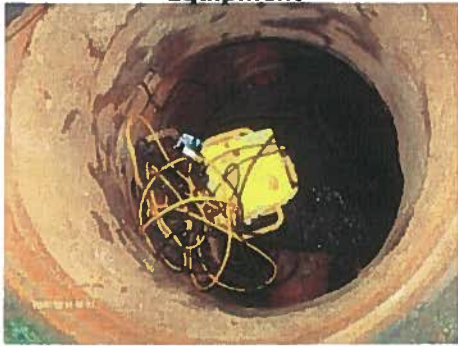
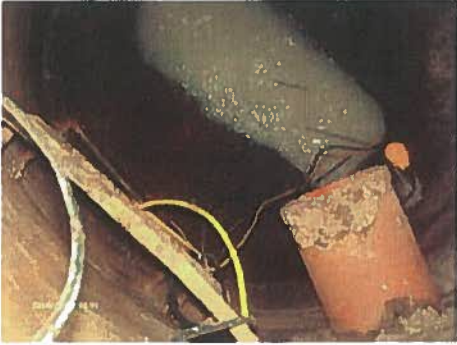
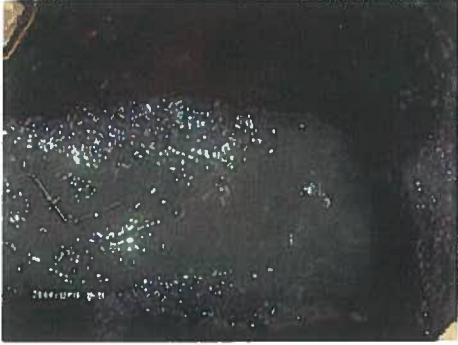
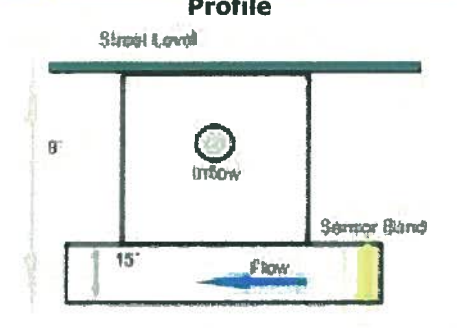
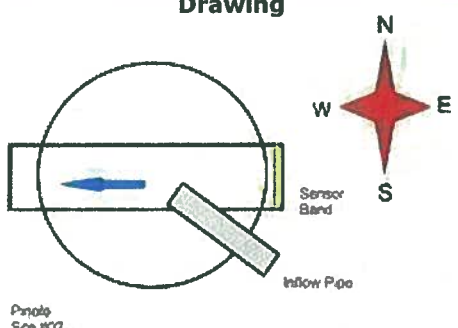
Site 2

This site is located in the southbound lane on Pinole Valley Road, between Granada Court and Helena Court. Traffic at this location was deemed to be low, and no additional traffic control was needed to perform safe entry. This manhole features a 15 inch inflow and outflow pipe constructed of concrete and deemed to be in good condition over the course of the study. This site also featured a secondary inflow that entered the manhole approximately three feet above the invert and is believed to have negligible impact in the monitoring application. Site investigations and photos show the flow to moderately turbulent by the presence of ripples in the flow; however, there was sufficient flow coverage at this site to mitigate any impact on the monitoring. Monitoring at this location was successful as hydraulic conditions at this site were deemed to be good.

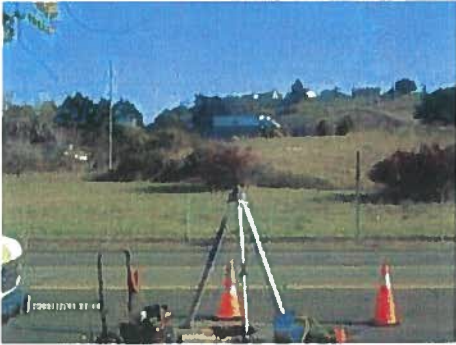
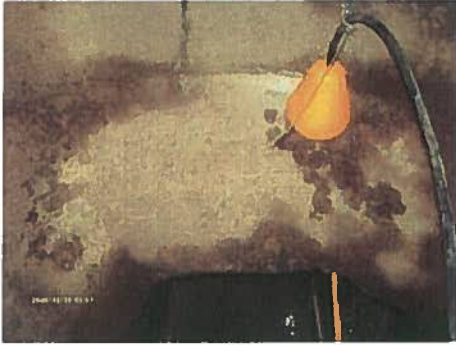
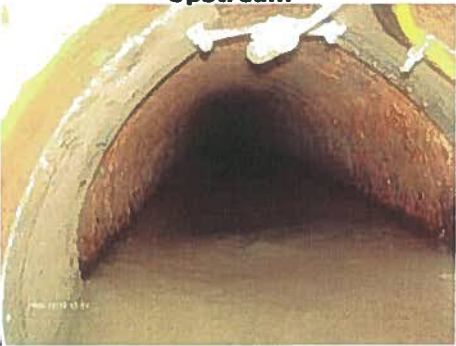
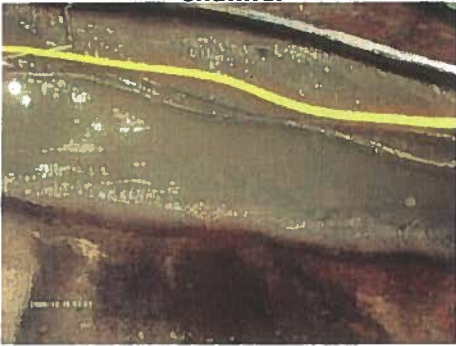
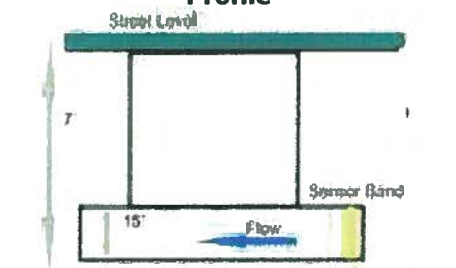
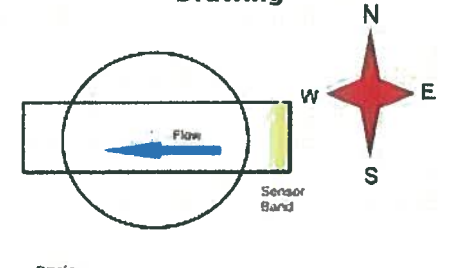
Site 3

This site is located in the southbound lane on Pinole Valley Road, between Henry Avenue and Interstate 80. Traffic at this location was deemed to be low, and no additional traffic control was needed to perform safe entry. This manhole features a 15 inch inflow and outflow pipe constructed of concrete and deemed to be in good condition over the course of the study. Site investigations and photos show the flow to moderately turbulent by the presence of ripples and waves in the flow; however, there was sufficient flow coverage at this site to mitigate any impact on the monitoring. Monitoring at this location was successful as hydraulic conditions at this site were deemed to be good.

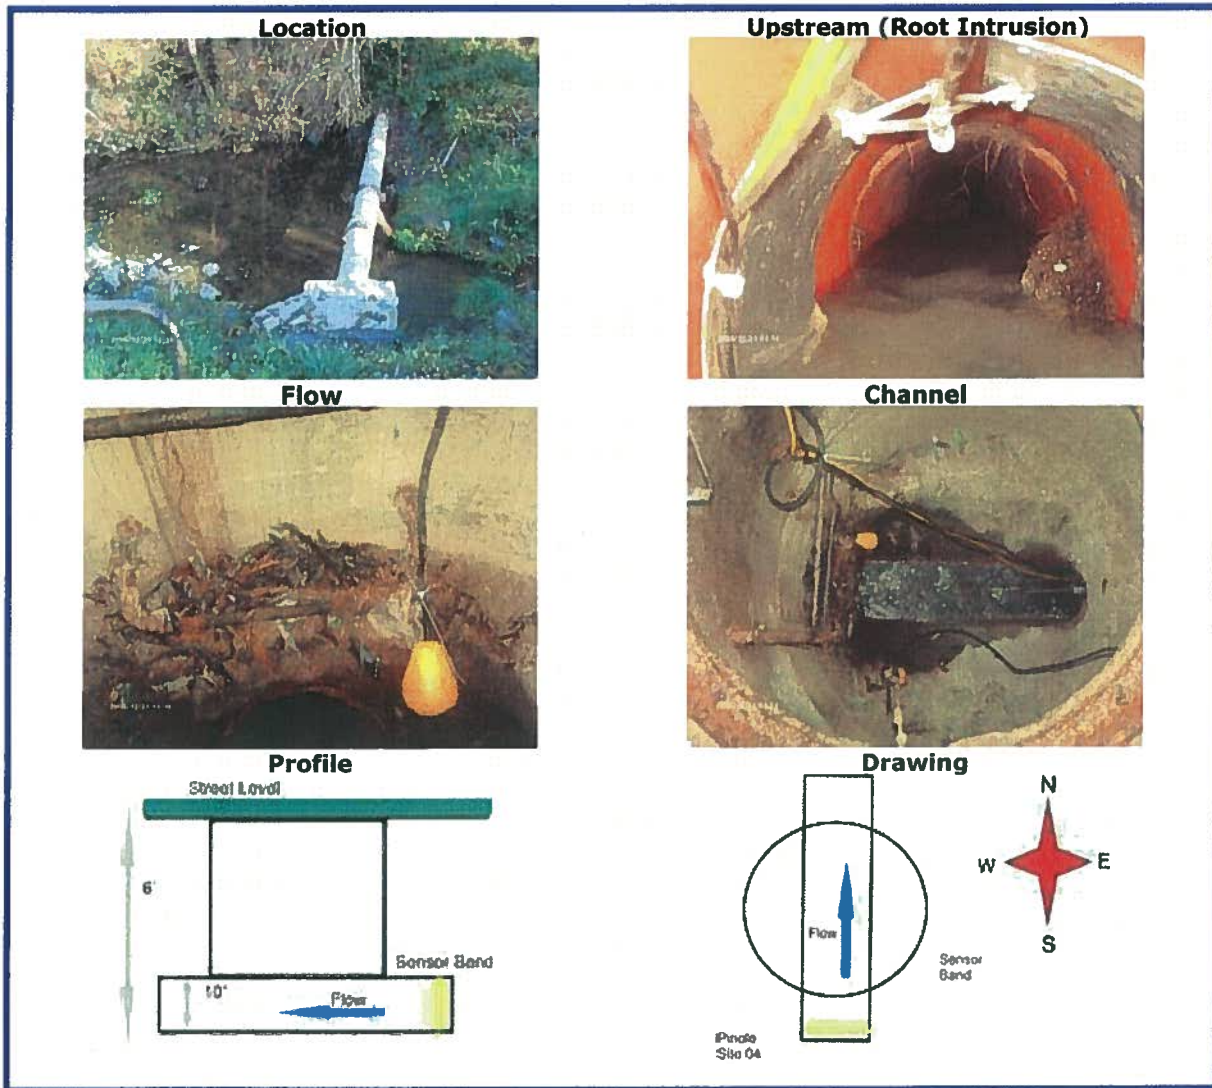
Site 4

This site is located near a foot bridge just South of Sarah Court on Pinole Valley Road. There was no traffic at this location and no additional traffic control was needed to perform safe entry. This manhole features a 10 inch inflow and outflow pipe constructed of concrete and deemed to be in good condition over the course of the study. Site investigations and photos show the flow to moderately turbulent by the presence of ripples and waves in the flow; however, there was sufficient flow coverage at this site to mitigate any impact on the monitoring. Site investigations indicated there were root intrusions at this location, which may be contributing to the turbulent flow conditions noted at this location. Overall monitoring at this location was successful as hydraulic conditions at this site were deemed to be good.

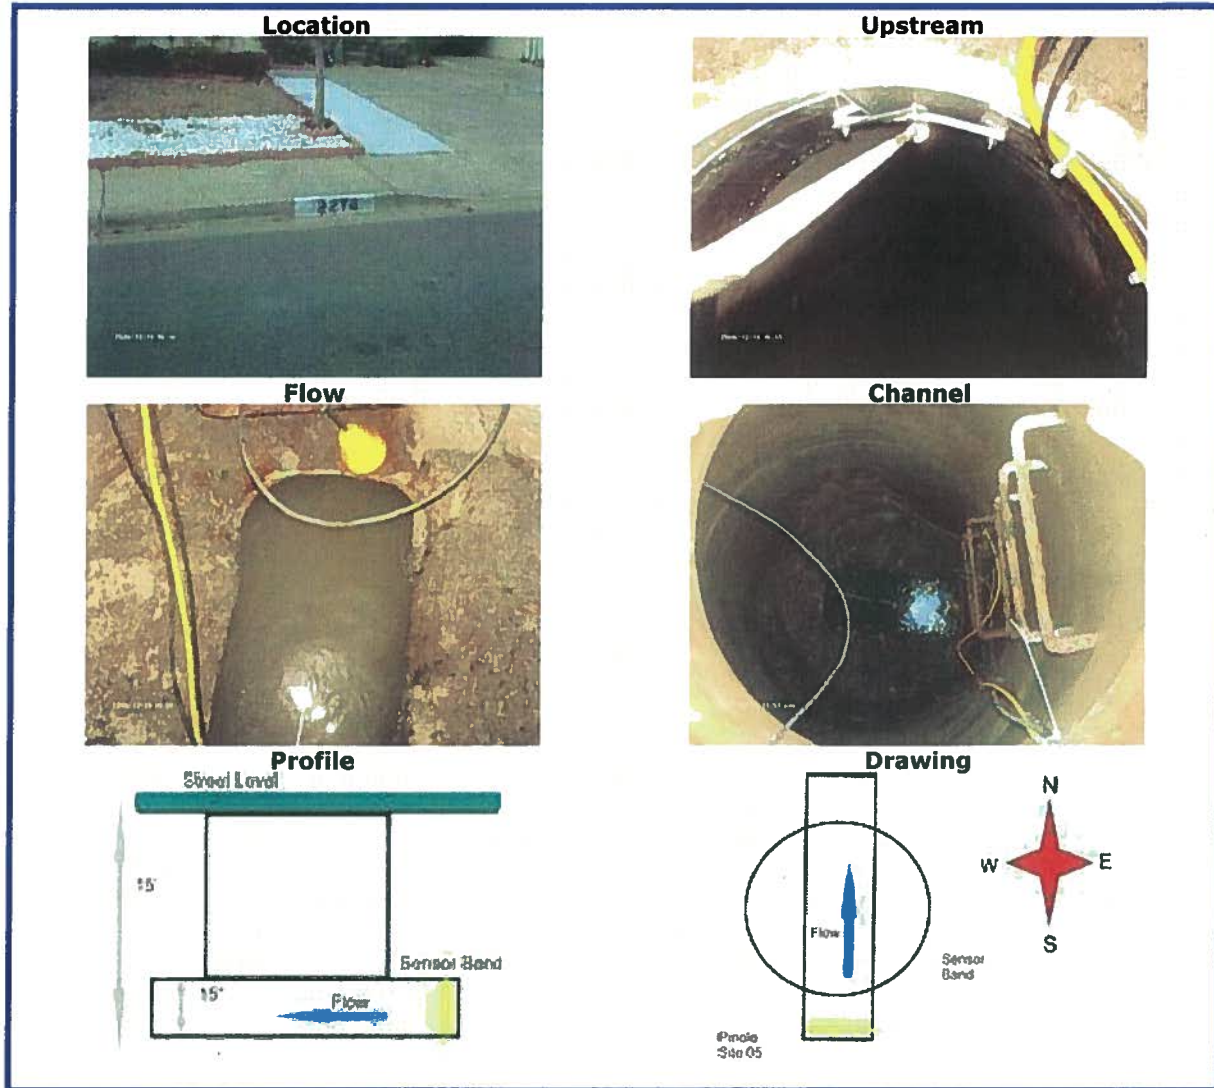
Site 5

This site is located near on Orleans Drive, between Zoe Court and Ramey Court. Traffic at this location was deemed to be low, and no additional traffic control was needed to perform safe entry. This manhole features a 15 inch inflow and outflow pipe constructed of concrete and deemed to be in good condition over the course of the study. Overall monitoring at this location was successful as hydraulic conditions at this site were deemed to be good.

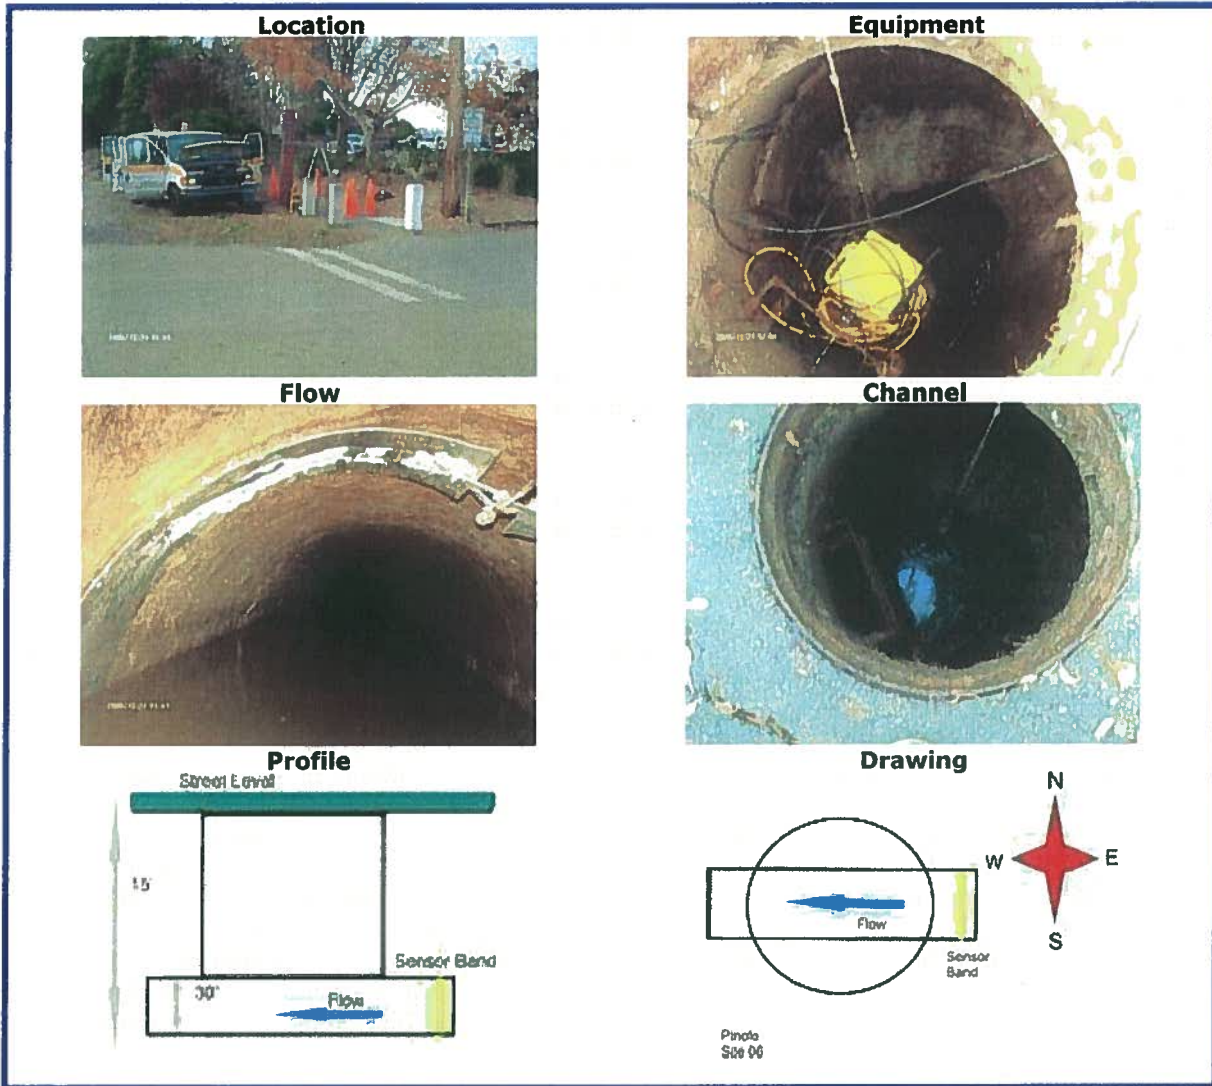
Site 6

This site is located near on the sidewalk of Bay Trail, just prior to the entrance to the waste water treatment plant. There was no traffic at this location and no additional traffic control was needed to perform safe entry. This manhole features a 30 inch inflow and outflow pipe constructed of concrete and deemed to be in good condition over the course of the study. Overall monitoring at this location was successful as hydraulic conditions at this site were deemed to be good.
