**CITY OF PINOLE
SEWER MASTER PLAN
MAY 2008**

SEWER MASTER PLAN

May 2008

CITY OF PINOLE
SEWER COLLECTION SYSTEM
MASTER PLAN

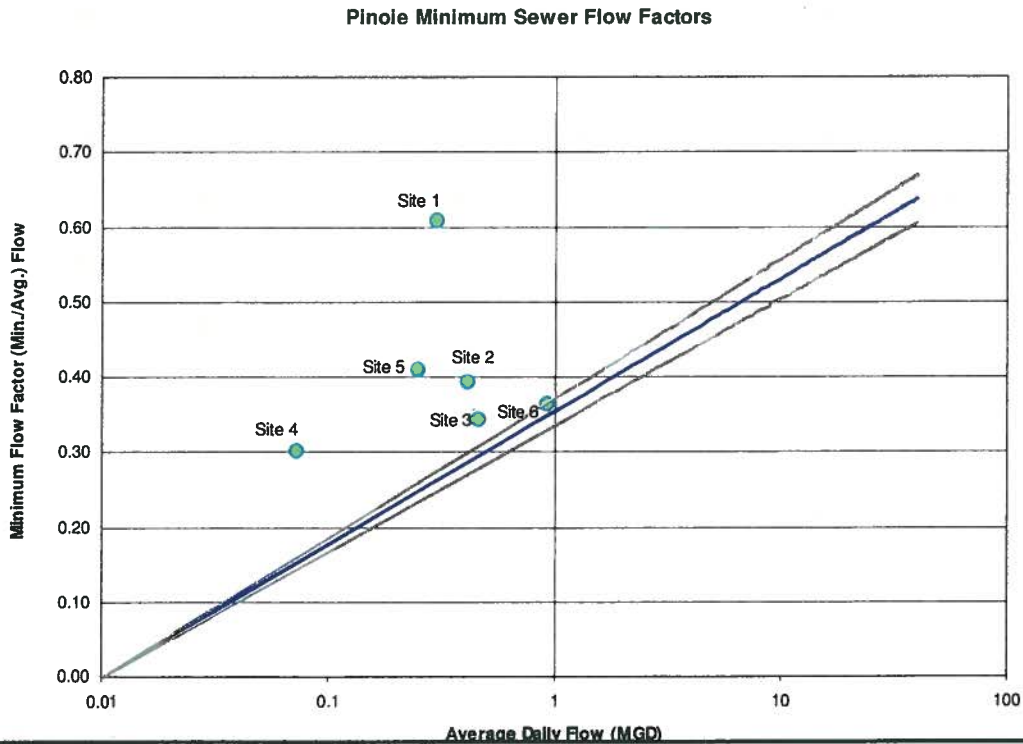
Figure 4-2 Minimum Flow Ratios

All sites in the Pinole system exhibit a higher than predicted minimum to average flow ratio. This is sometimes used as a guide to indicate higher nighttime infiltration rates Figure 4-2 shows the predicted values and the observed values. The blue line is the expected minimum flow factor based on WEF MOP 9 (1988). The gray lines are the 5% deviations. Interpretation – Points lying above the expected minimum flow factors exhibit higher minimum flow rates that are expected. Overall high groundwater infiltration is the likely culprit.

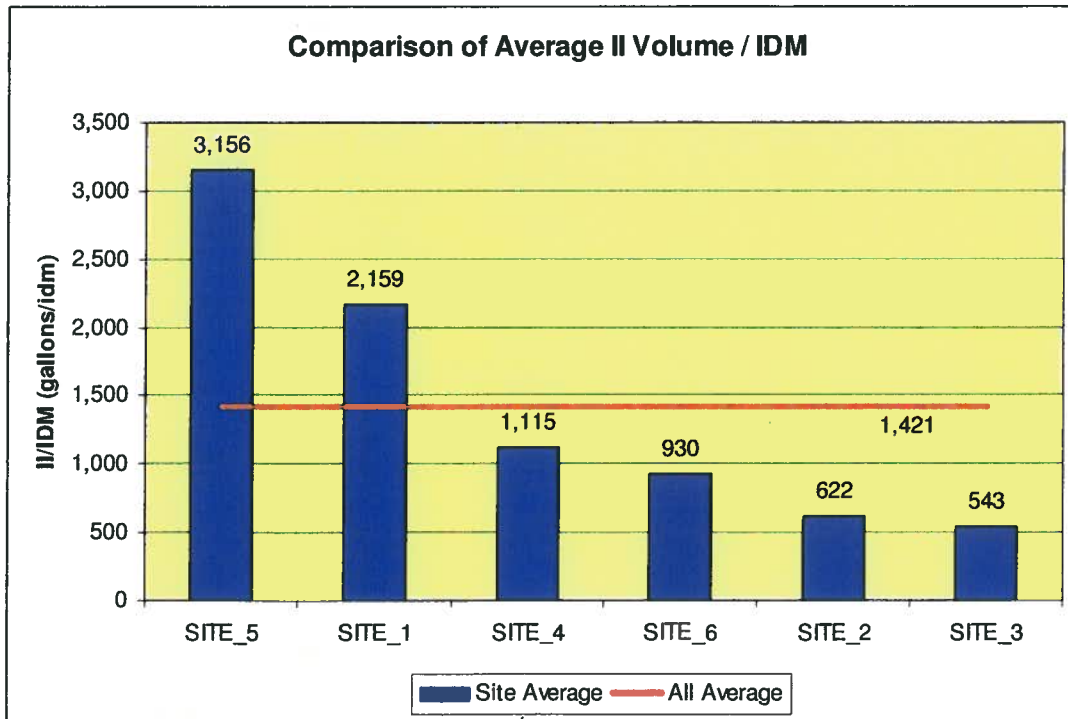
Figure 4-3 Increase in flow volume (Infiltration)

Shown graphically in the following figure, Site 5 shows the highest average increase in flow volume (infiltration)

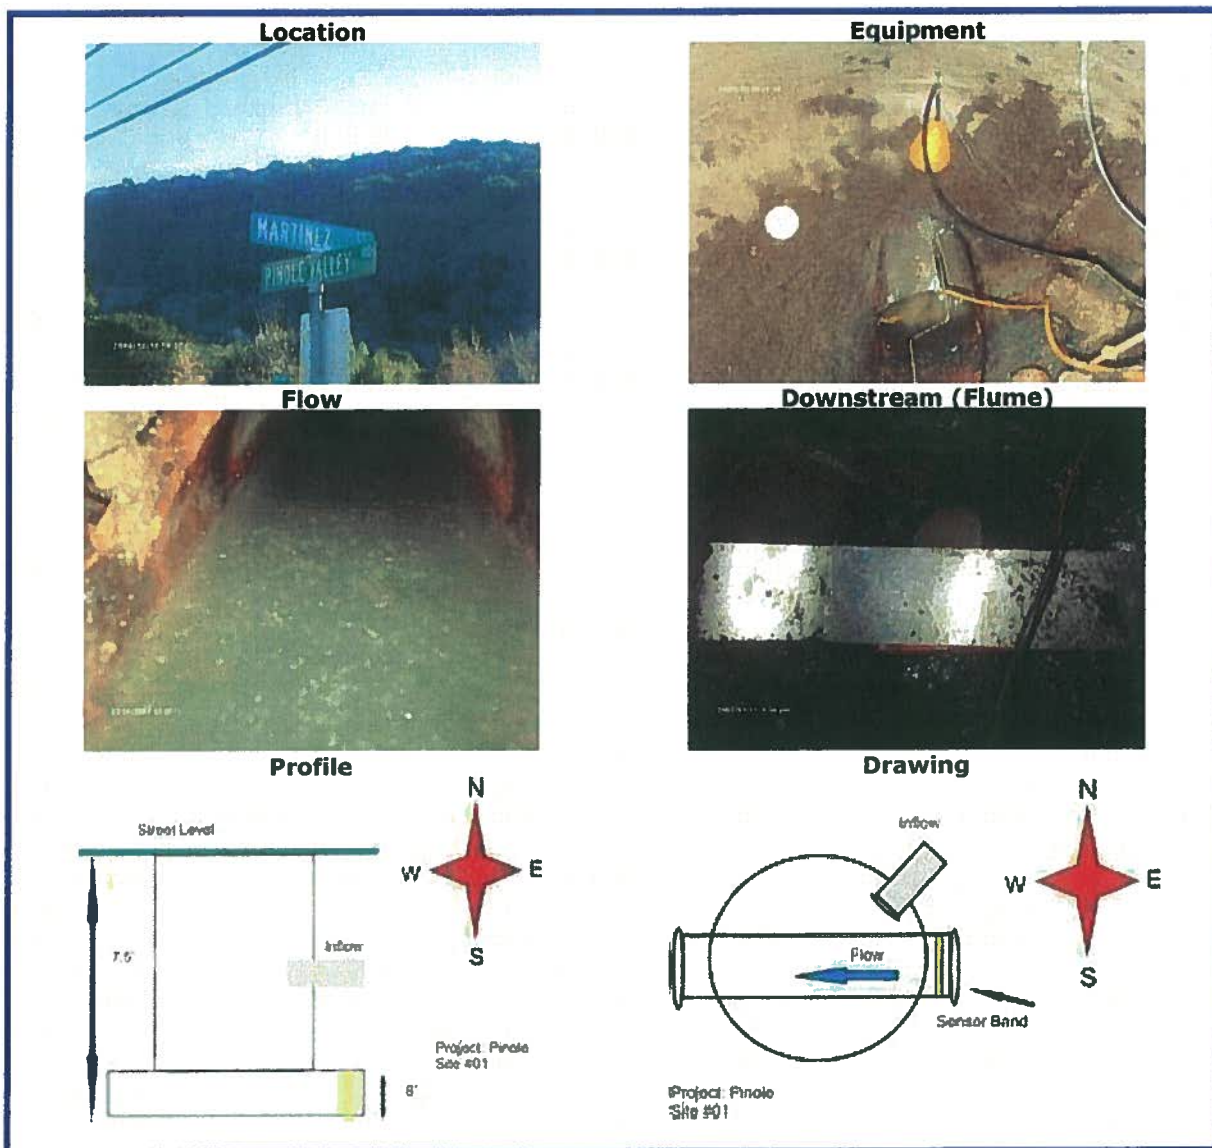
Site 1

This site is located on Pinole Valley Road, near the entrance to Martinez Court. Traffic at this location was deemed to be low, and no additional traffic control was needed to perform safe entry. This manhole features a 10 inch inflow and outflow pipe constructed of concrete and deemed to be in good condition over the course of the study. This site also featured a secondary inflow that entered the manhole approximately three feet above the invert and is believed to have negligible impact in the monitoring application. This location also had a flume installed to overcome hydraulic challenges associated with low flow. Monitoring at this location was successful as hydraulic conditions at this site were deemed to be good.

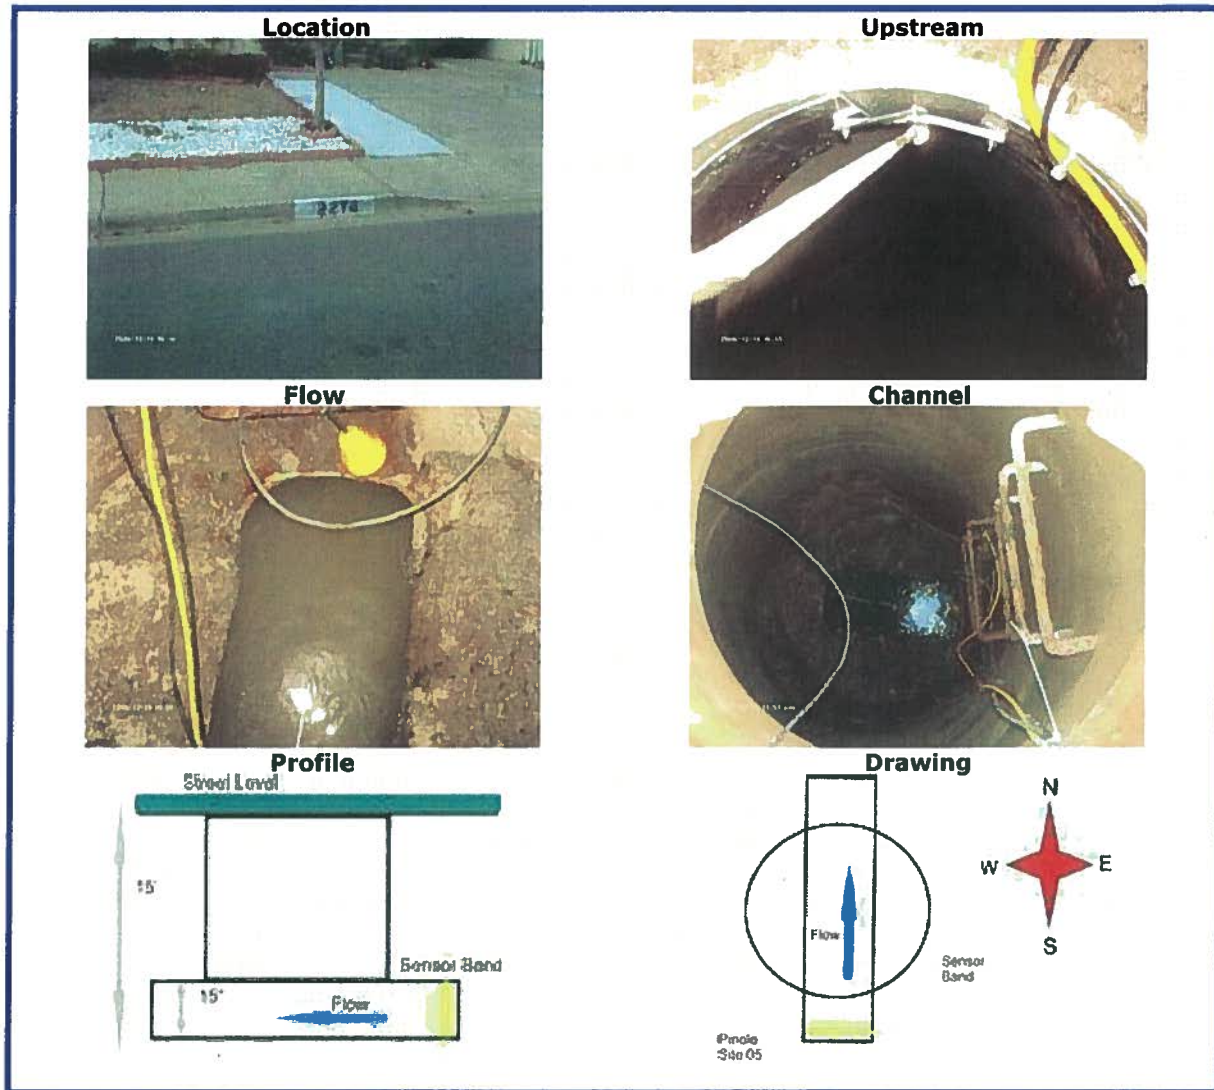
Site 5

This site is located near on Orleans Drive, between Zoe Court and Ramey Court. Traffic at this location was deemed to be low, and no additional traffic control was needed to perform safe entry. This manhole features a 15 inch inflow and outflow pipe constructed of concrete and deemed to be in good condition over the course of the study. Overall monitoring at this location was successful as hydraulic conditions at this site were deemed to be good.
